SPEED WEEK

BONNEVILLE SALT FLATS

AUGUST 13-19 2016

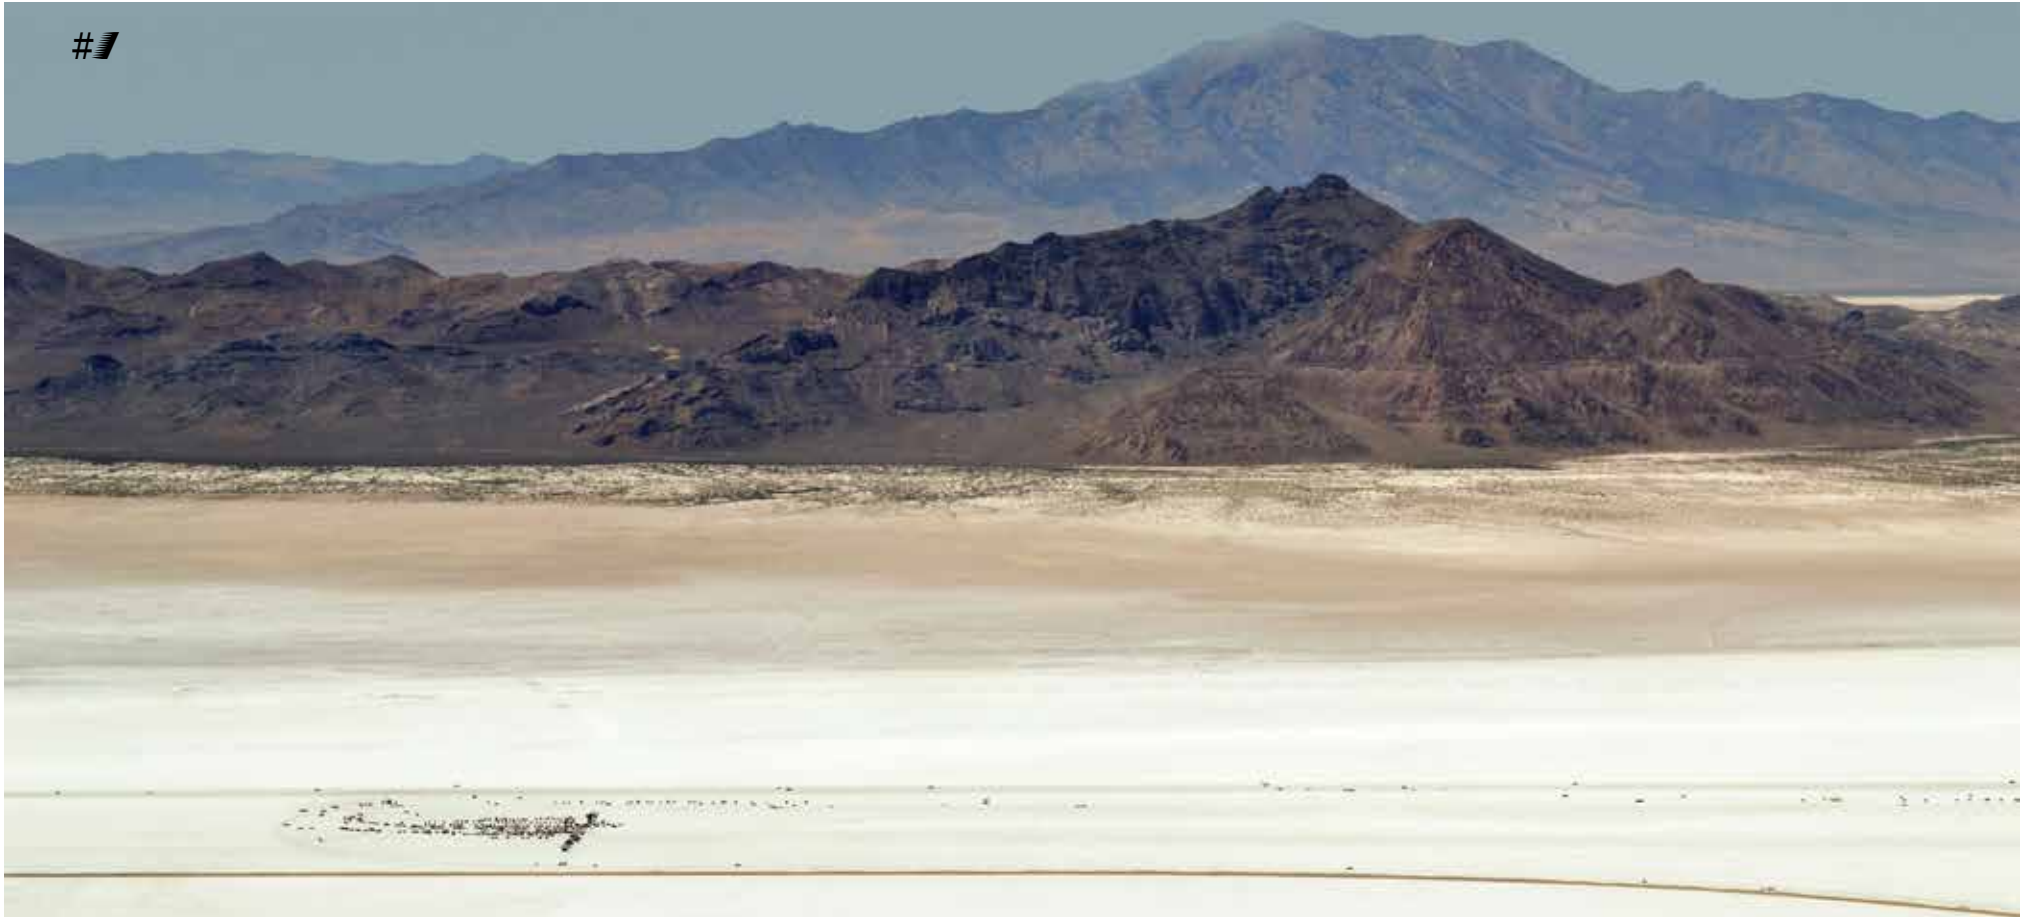
Starting Line, long course looking north/northwest with Tetzlaff Peak in the center background. Sharp brown line in lower portion is the Salduro Loop mud dike. Note the dramatic surface differences outside the loop where salt has been drawn off by mining operations through the years. All encroaching vegetation is new to the landscape since 2000. The 3 horizontal lines etched into the near mountains are ancient seashores. The presence of vegetation north of the track is an indication of severe-

ly depleted salt thickness as these plants will not grow in the mineral rich surfaces. For many decades there was solid hard white salt (dense cemented halite) all the way to the base of the Silver Island Mountain Range. The narrow remaining “finger” of salt now has a maximum thickness in the range of ½ inch and does not support the weight or power application of many of these racing machines.

Long Course starting Line and staging lanes, close up. Racers arrive from pits located out of frame 2 miles to the left. Brown line near top is Salduro Loop mud dike.

ry access route between the pit area and the pavement in the lower half of this photo going out to the right is so thin that the brown underlying mud is showing through. The mud Salduro Dike has sloughed off over the years and spread across the surface further diluting the salt surface.

Vehicles located at perimeter points are spectators. Note the prima-

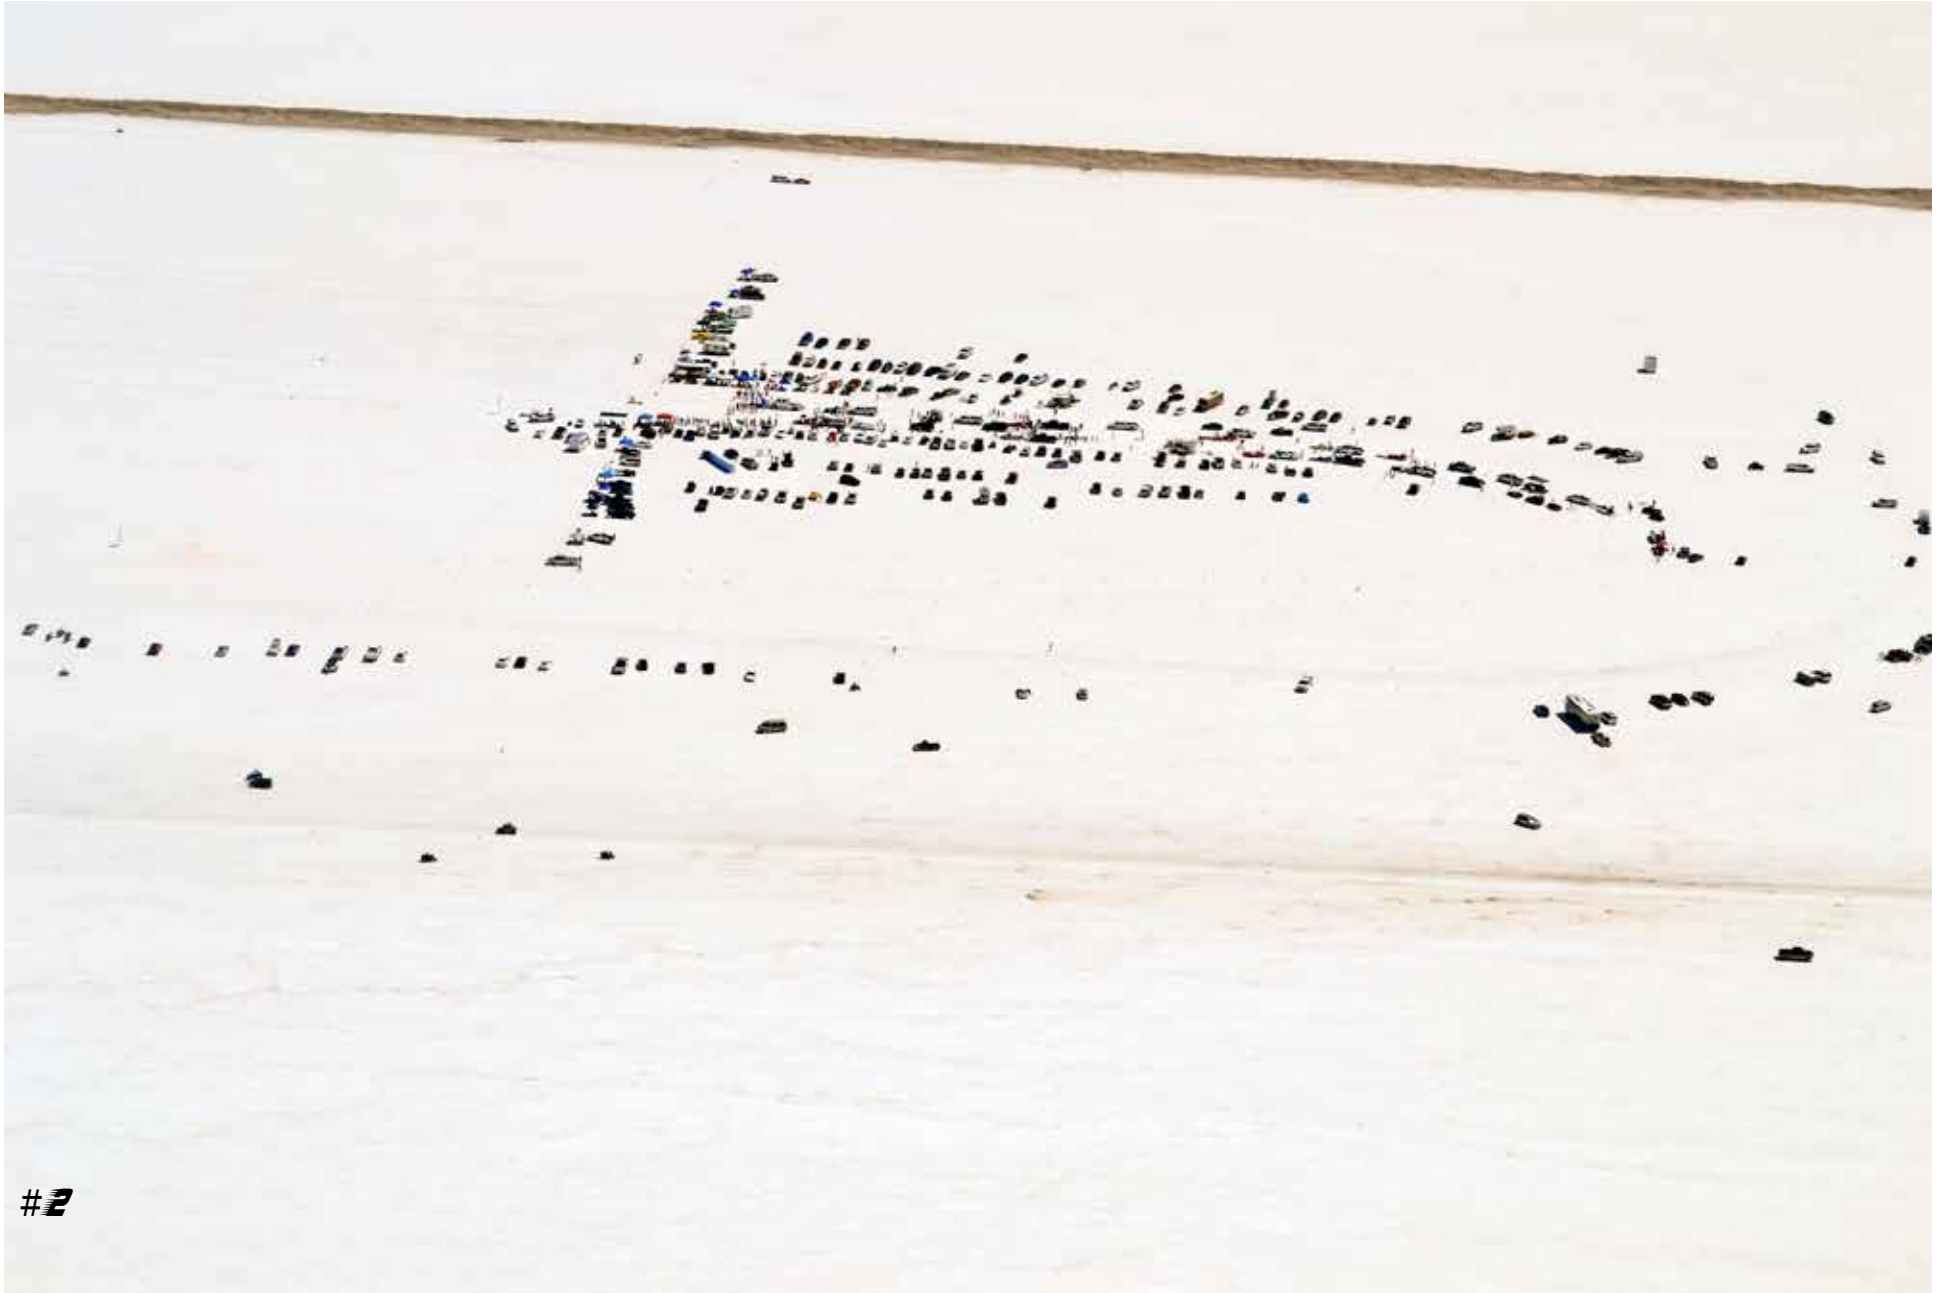
Looking nearly due east towards Salt Lake City. Long course starting line in lower portion, short course and rookie course located at top around the bend of the Salduro Loop mud dike.

the track surfaces and anywhere traffic has been moving, further demonstration of the thin fragile nature of the remaining salt on this basin.

Inside the solid white Salduro Loop the salt crust was measured to be more than 8 inches deep in 2016. Access road for participants and spectators is the glazed road near bottom of frame. Note the gray appearance of

In 1966 the Salduro Loop was abandoned by mining and set aside. It has been suggested that as part of a deal that was worked out between the mining and the State of Utah, it was to remain a “pristine” area from which a less than accurate “view” the salt could be relied upon when from the I-80 rest stop area.

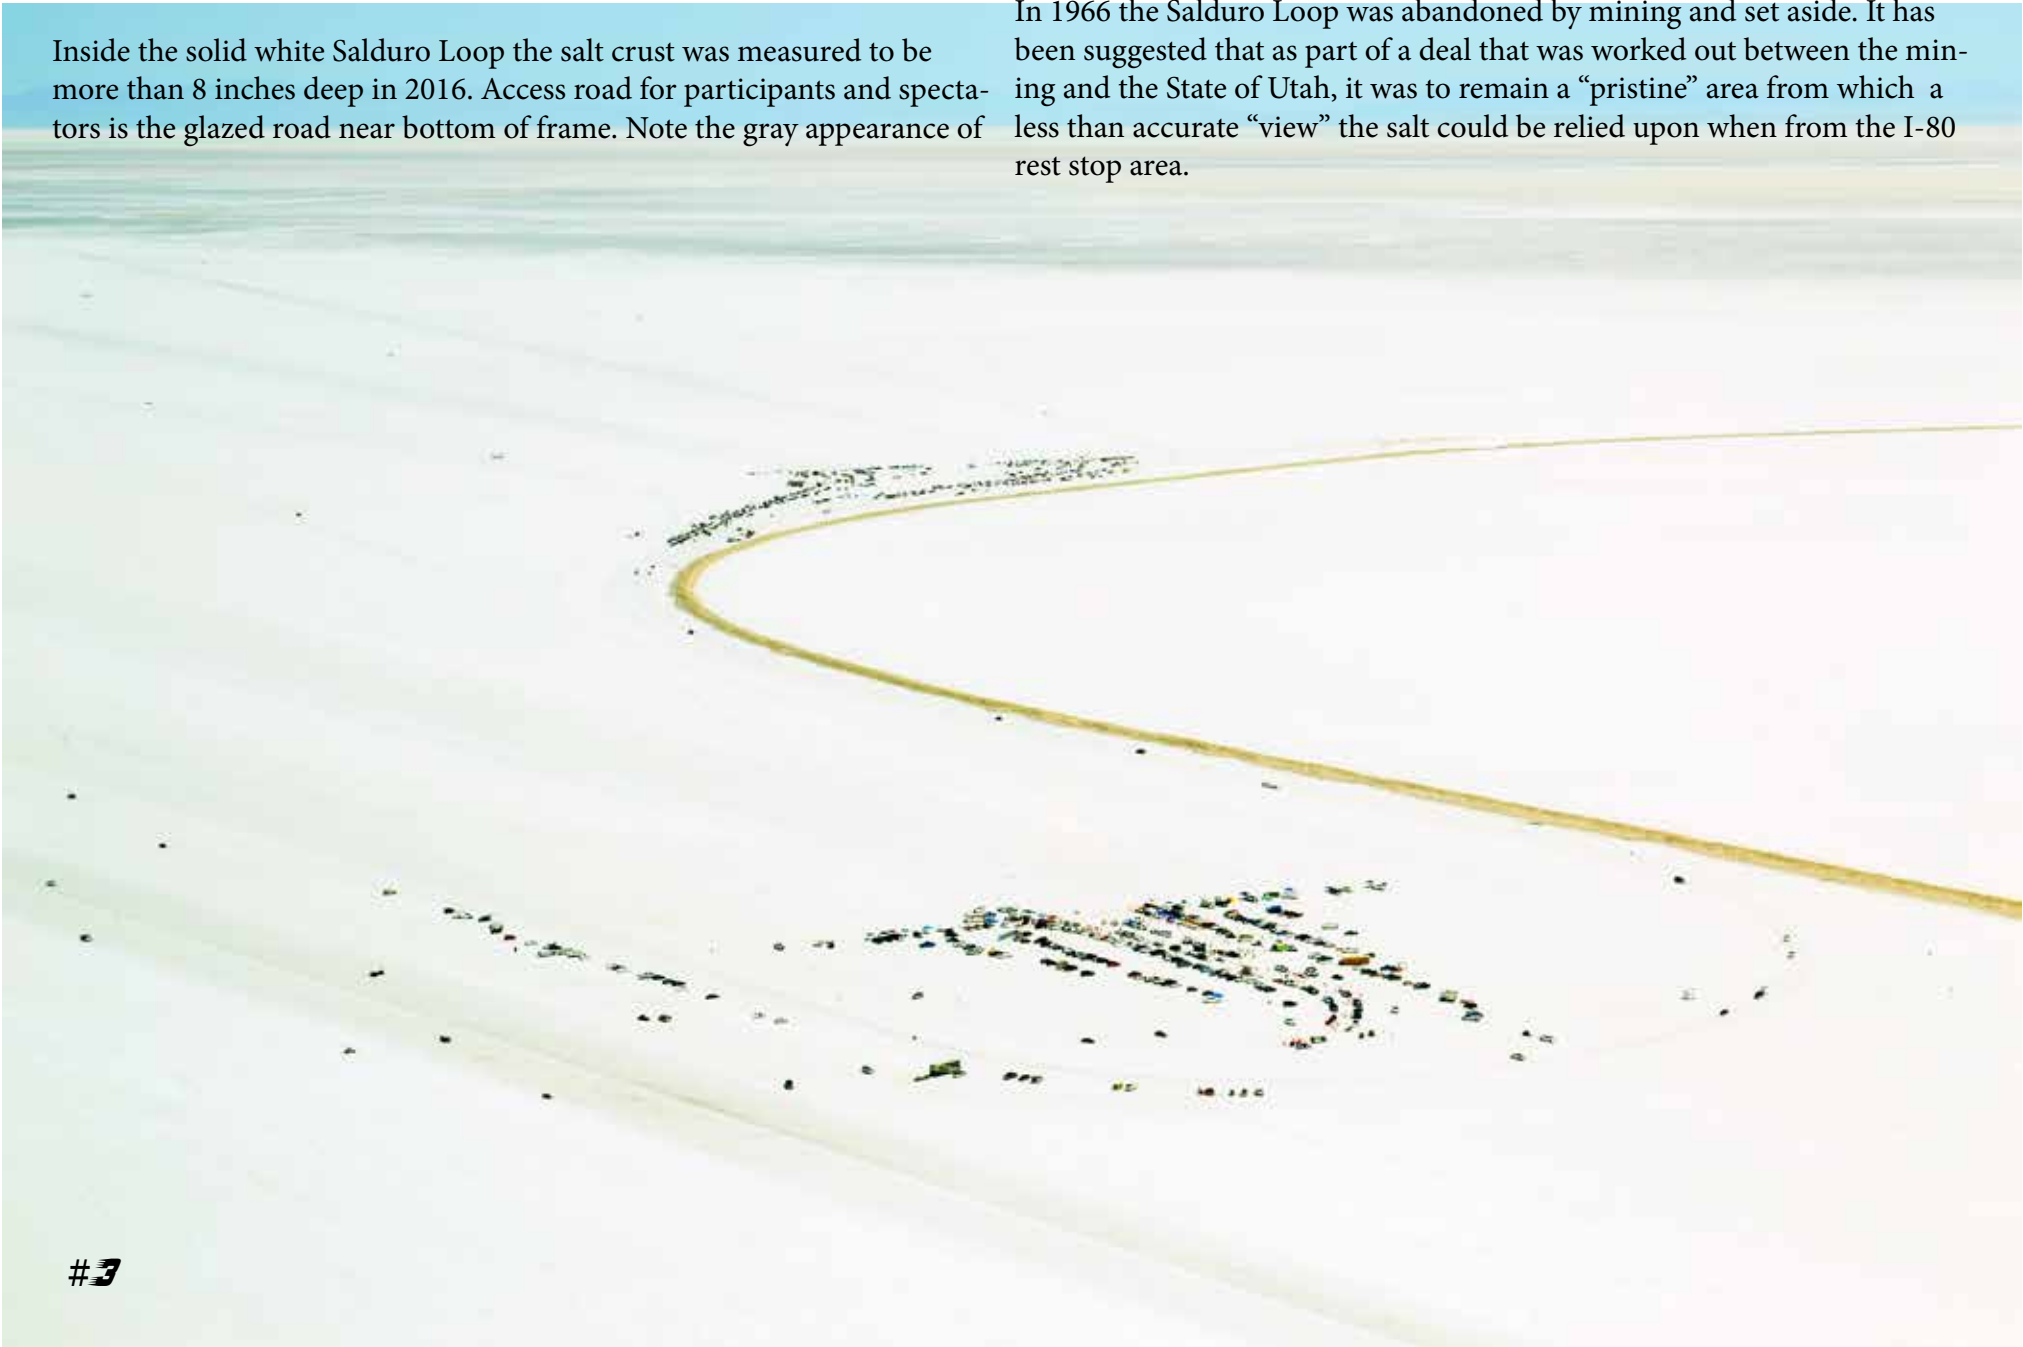
Close up of Short Course and Rookie staging lanes located just beyond the southern most bend of Salduro mud dike. Line of cars near top are spectators watching speed machines on long course. Glazed arcing road at right is short course return road. The original Salduro Ditch is on the left of the dike in this view, now predominantly filled with salt deposits to the level of the surface.

Another clear demonstration of the width and amount of erosion of the Salduro Loop dike in this clear overhead view. The long alluvial like slope of the dike on the right side is a result of wind, rain, and surface water exposure over the years.

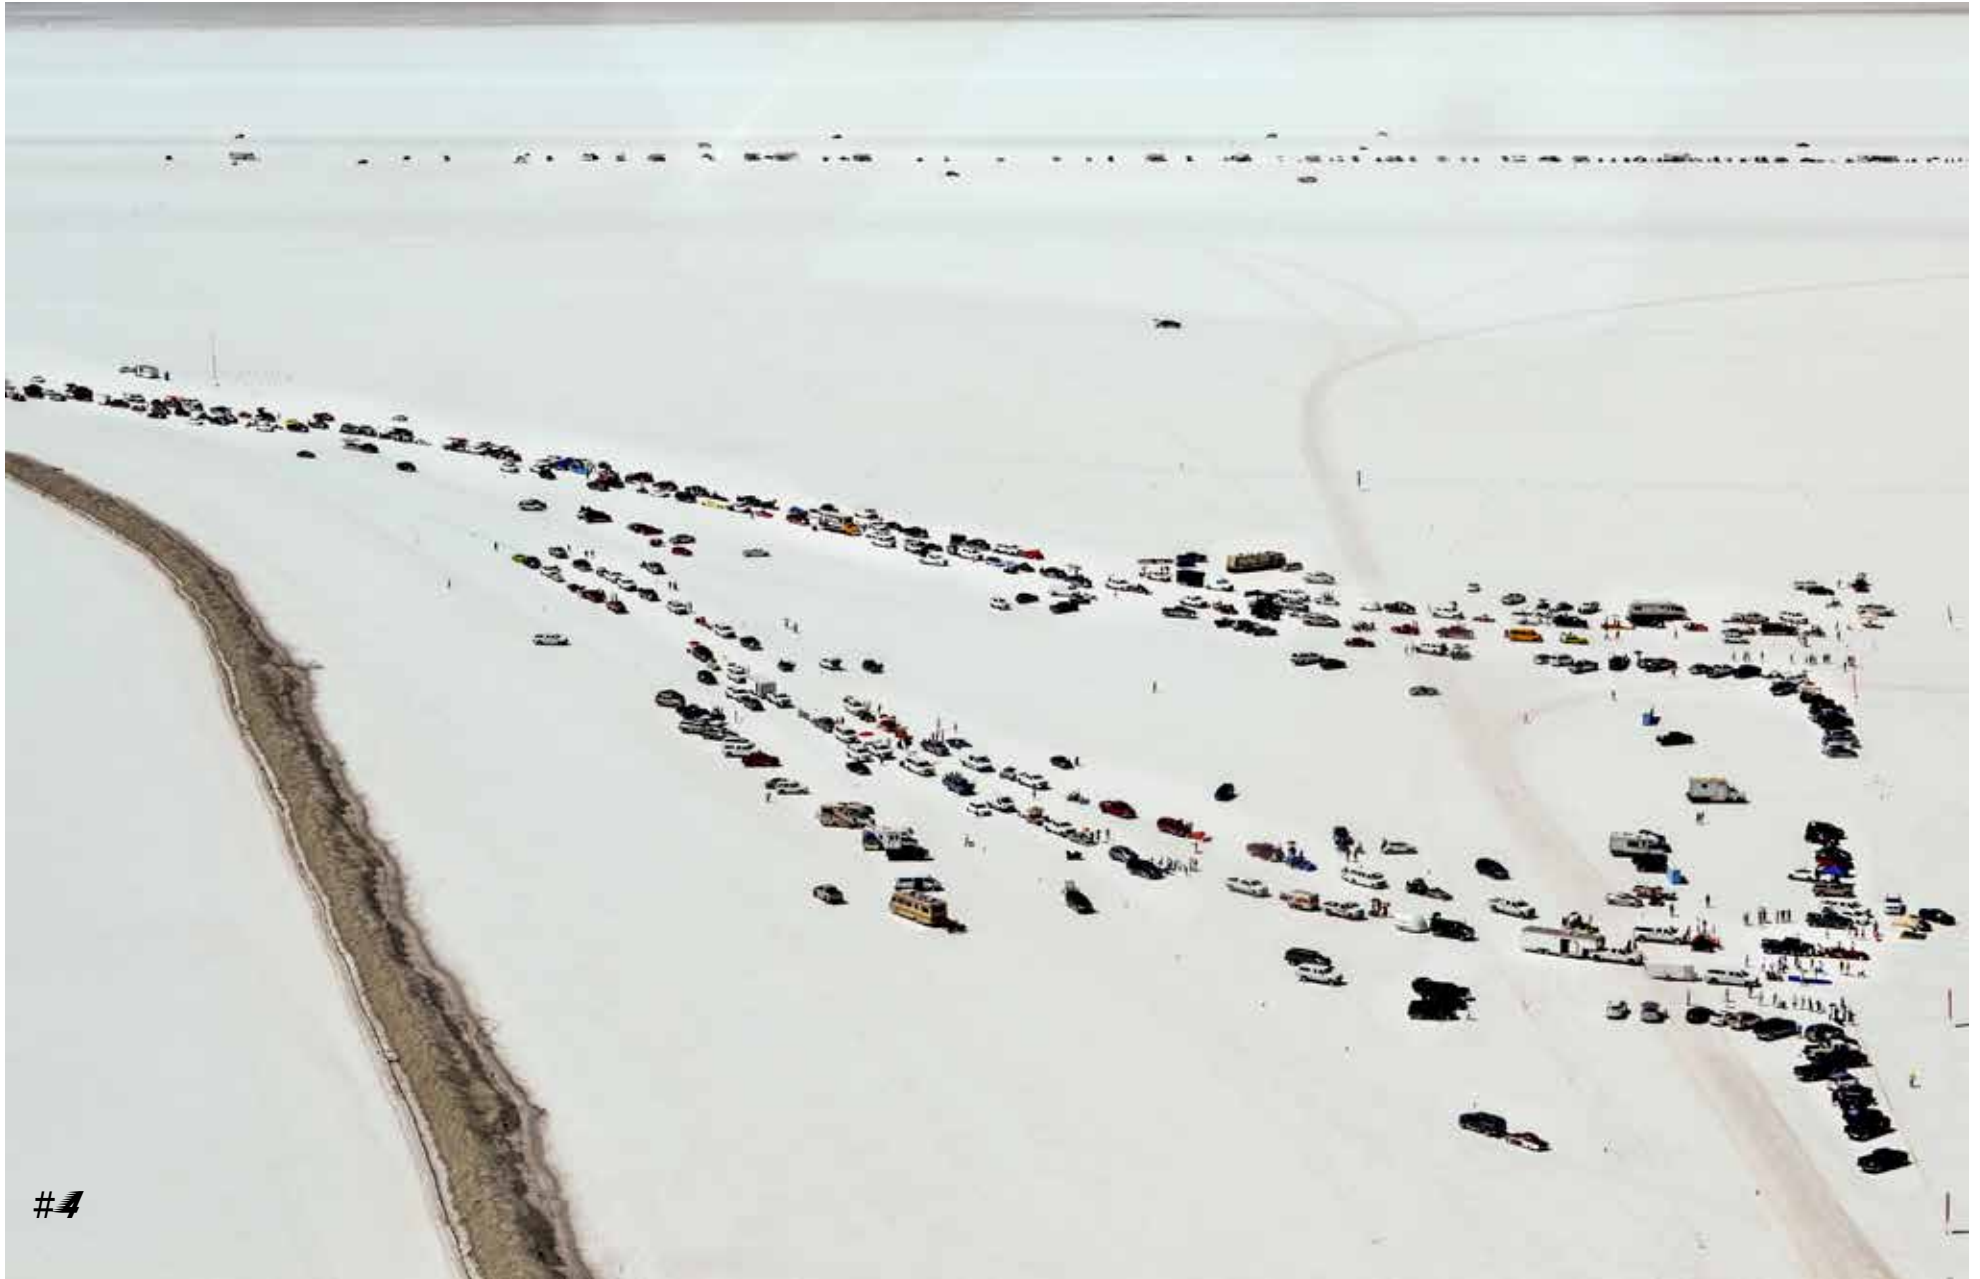
Looking southwest from Long Course 4.5 mile line along the international course heading back towards the starting line. Pits on right. Salduro Loop mud dike is the hard scribed right angled line near top. In the distance are the evaporation ponds of Intrepid mining, containing millions of tons of waste salt.

SCTA Timing Tower trailer for long course vehicles is to the left of the pit. Long course lanes are defined by blue lines. Only one lane is used on any given day, moving when the salt crust deteriorates below safe conditions. All three lanes were required to support 6.5 days of racing. The racing conditions were so bad that most high-speed participants left by Tuesday.

The course from the southwest to the northeast at about 54 degrees off true north

The brown rings seen below are marks produced by the track drag breaking through the extremely thin salt surface, creating a very dangerous soft spot entering the fastest timed mile of the race course. The small black spots just below the brown rings are the four mile markers on the long course, the entry point for the final timed mile.

Observe the tan area to the right of the course at about the 4 mile. That area is a portion of the original course that had to be abandoned during early preparation due to insufficient salt to even be "polished" smooth. The salt at this point is less than $\frac{1}{4}$ inch thick and this is where the fast cars are laying down maximum power. Salt this thin is very dangerous to the high speed race car.

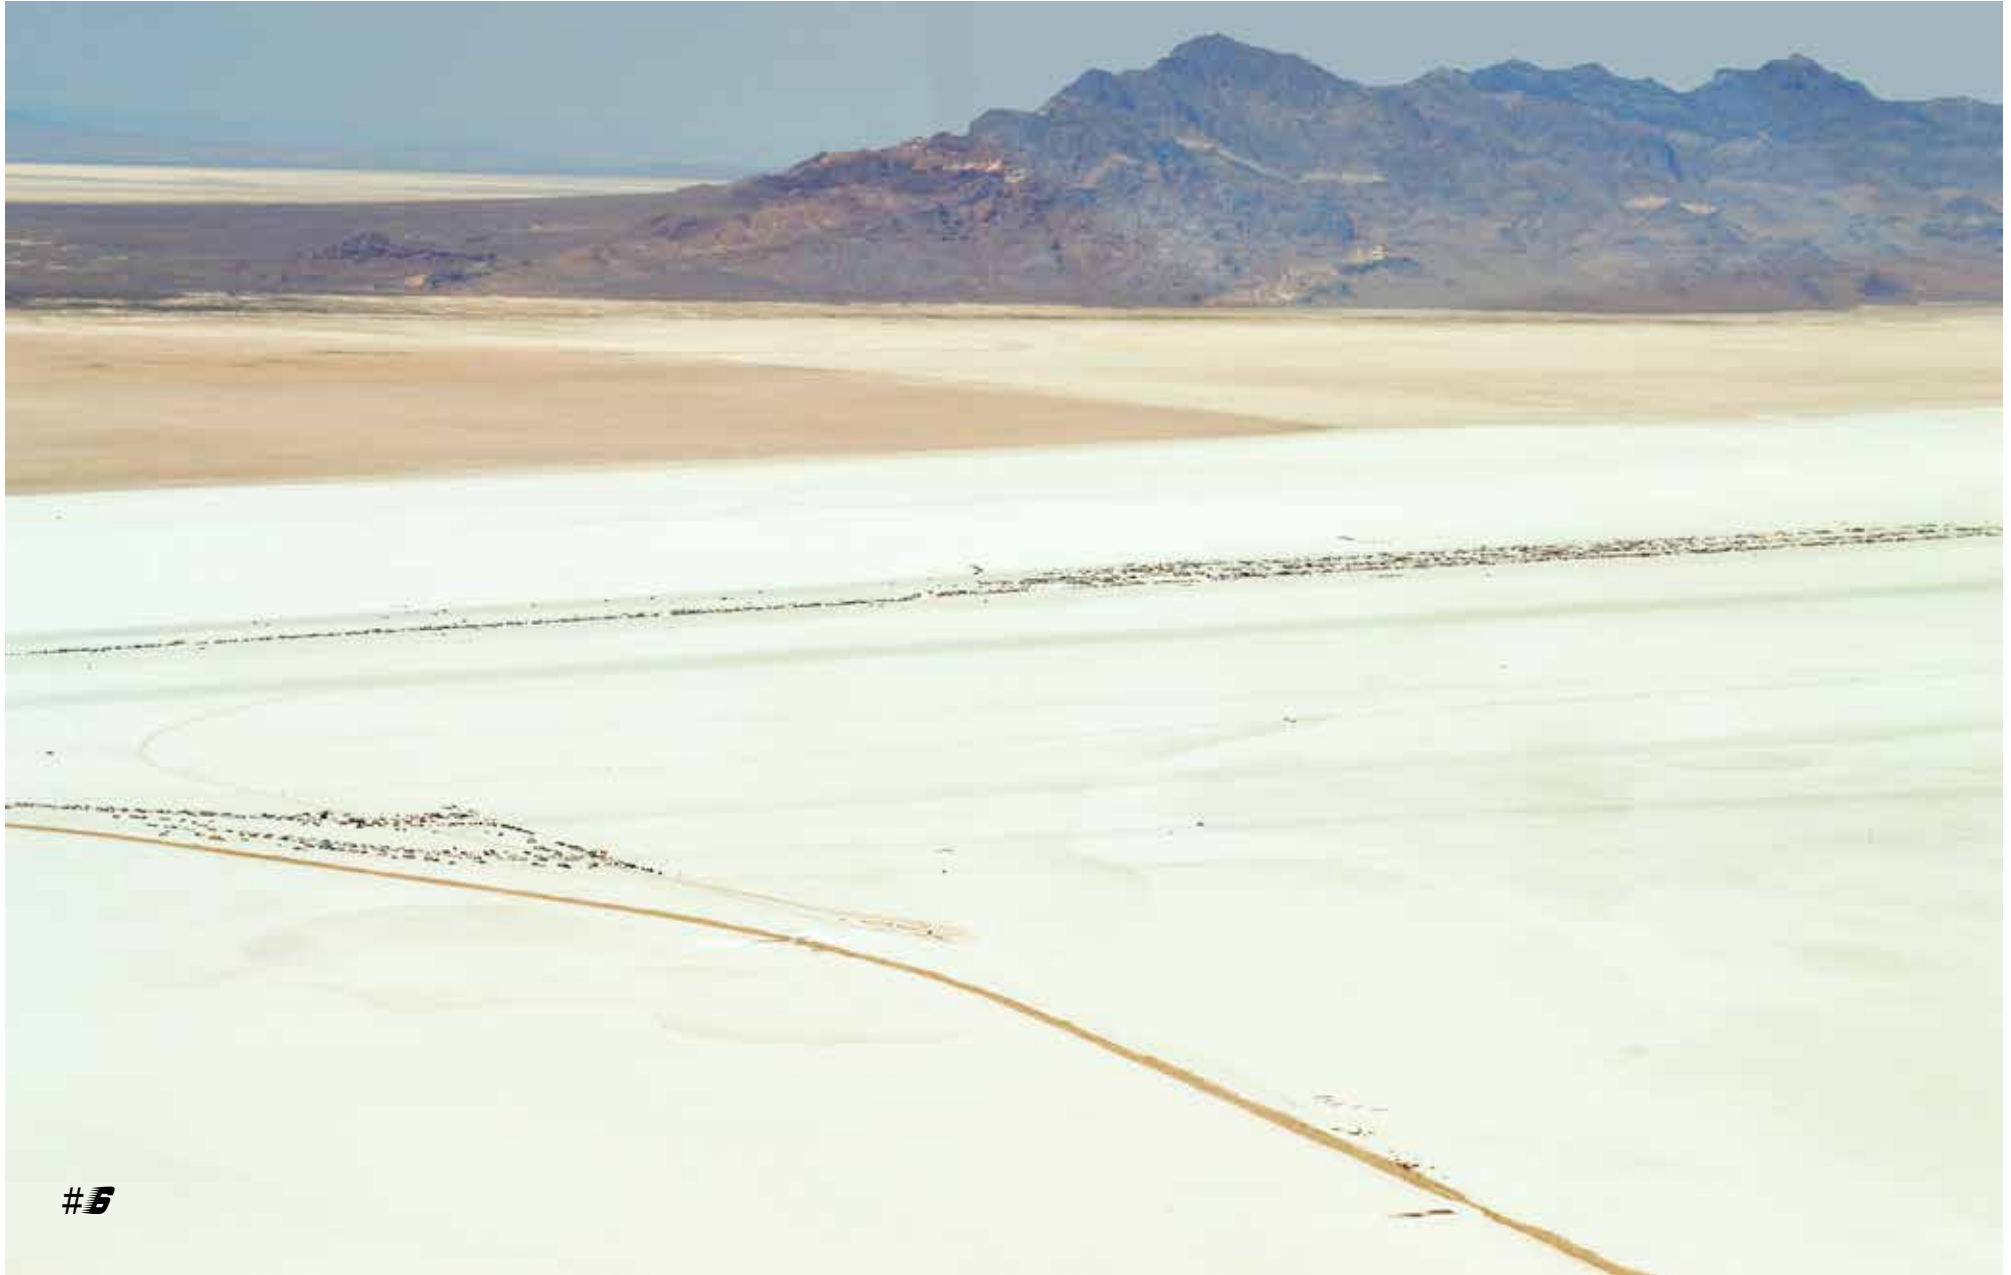
Looking toward the North showing Cobb Peak near the north end of the Silver Island Mountain Range. Salduro Loop mud dike arcs along lower left. Short Course and Rookie course staging lanes hug the dike as the race course fan out to the right toward Floating Mountain. Top line of vehicles are spectators that stretch from Long Course starting line 2 miles North. As top line thickens these are the SCTA participant racing pits that extended for more than a mile along the Silver Mountains comprised of five rows.

The glazed, gray line in between is the long course race course. The dark dot between the glazed race course is the SCTA Timing Tower trailer. The dark brown surfaces indicating minimal salt thickness north of the track and towards Floating Island.

Note: the severe thinning of salt just behind pit area with encroaching flora all along the base of the mountain roadway.

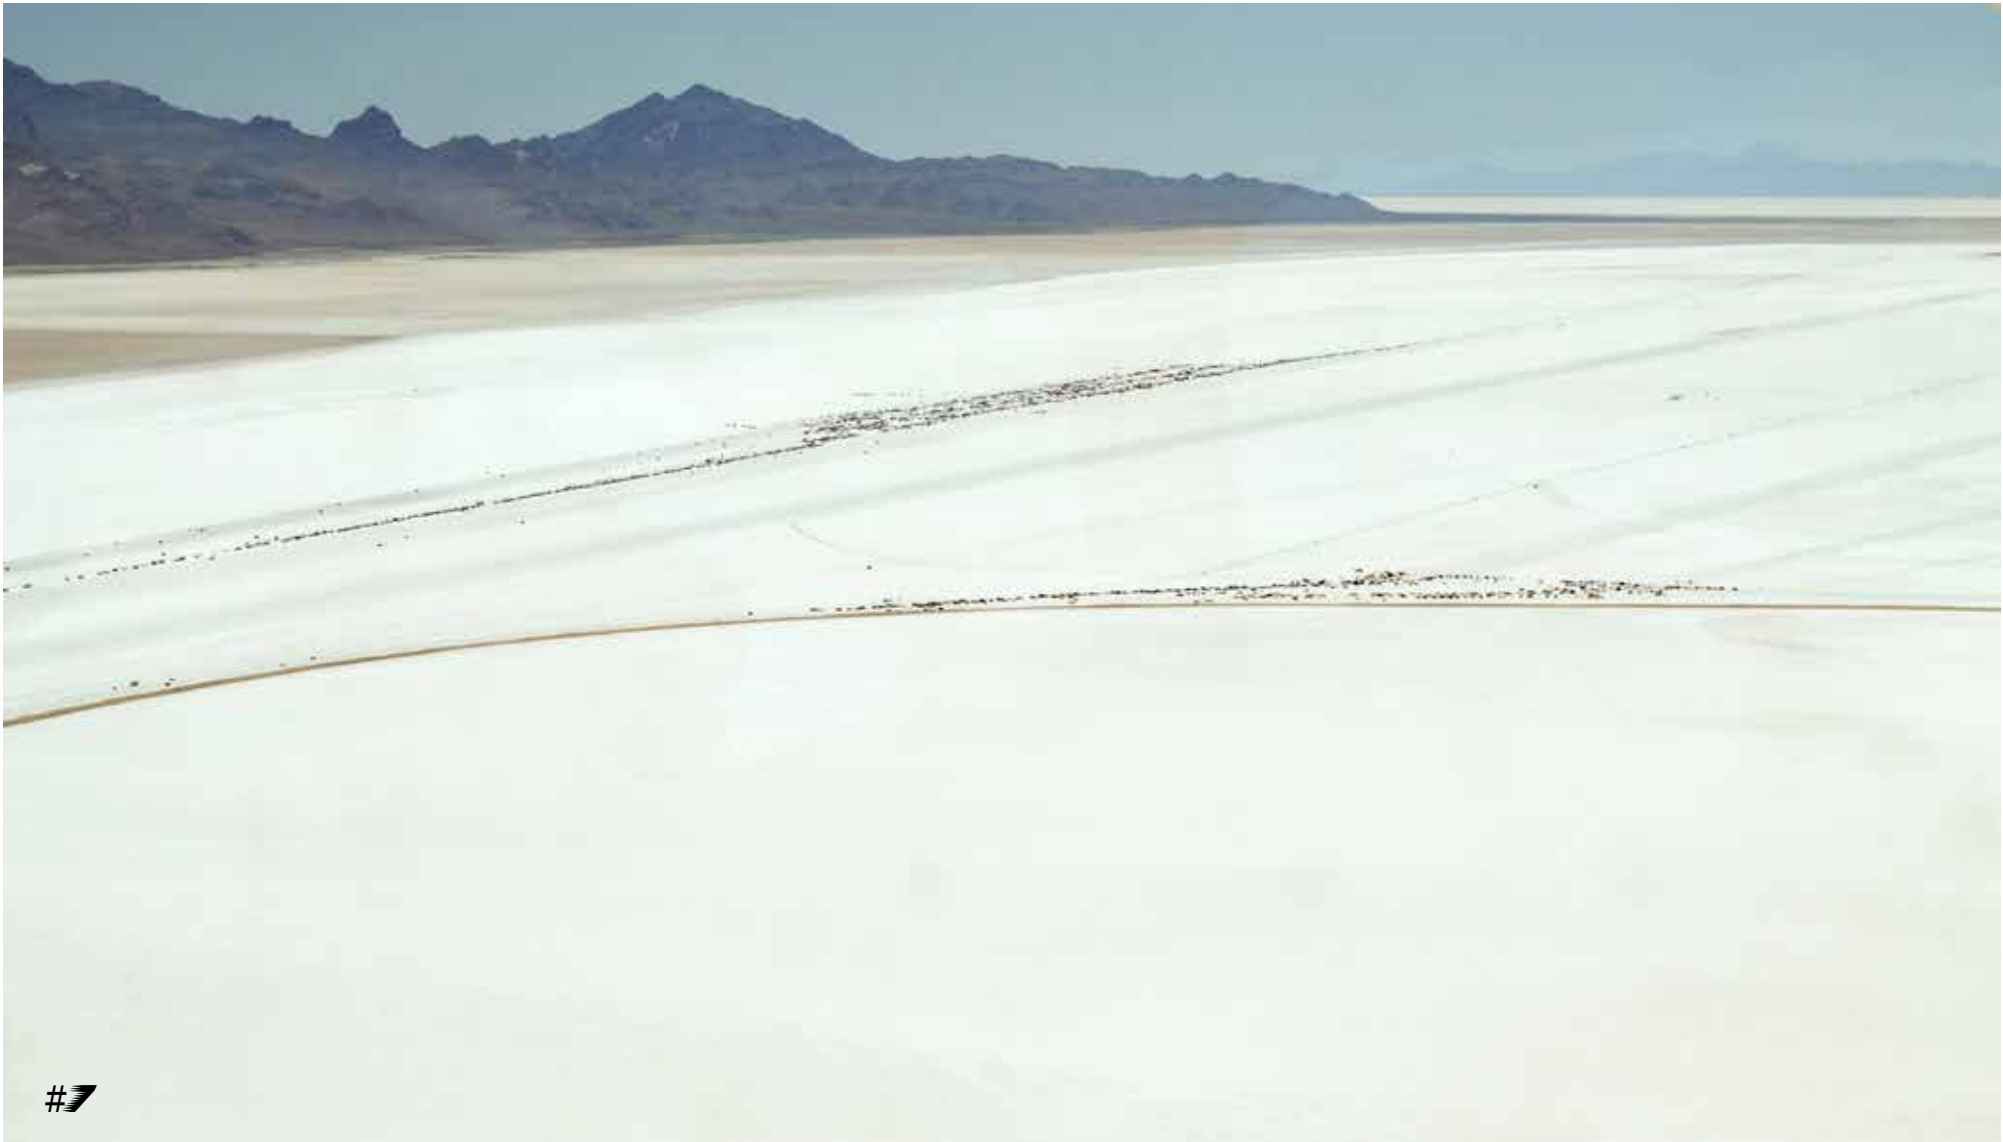
View looking south across the pit area of the 2016 Speed Week, Salduro Loop and I-80 across the center of the photo with the massive extent of salt on the south side of I-80 laid down by mineral extraction evaporation operations. This salt extends all the way south to the Deep Creek Mountain Range covering over 100 square miles and is multiple feet thick in many areas.

The arcing line in the middle of the image is the Salduro Loop mud dike. In the distance are the evaporation ponds of Intrepid mining, containing millions of tons of waste salt.

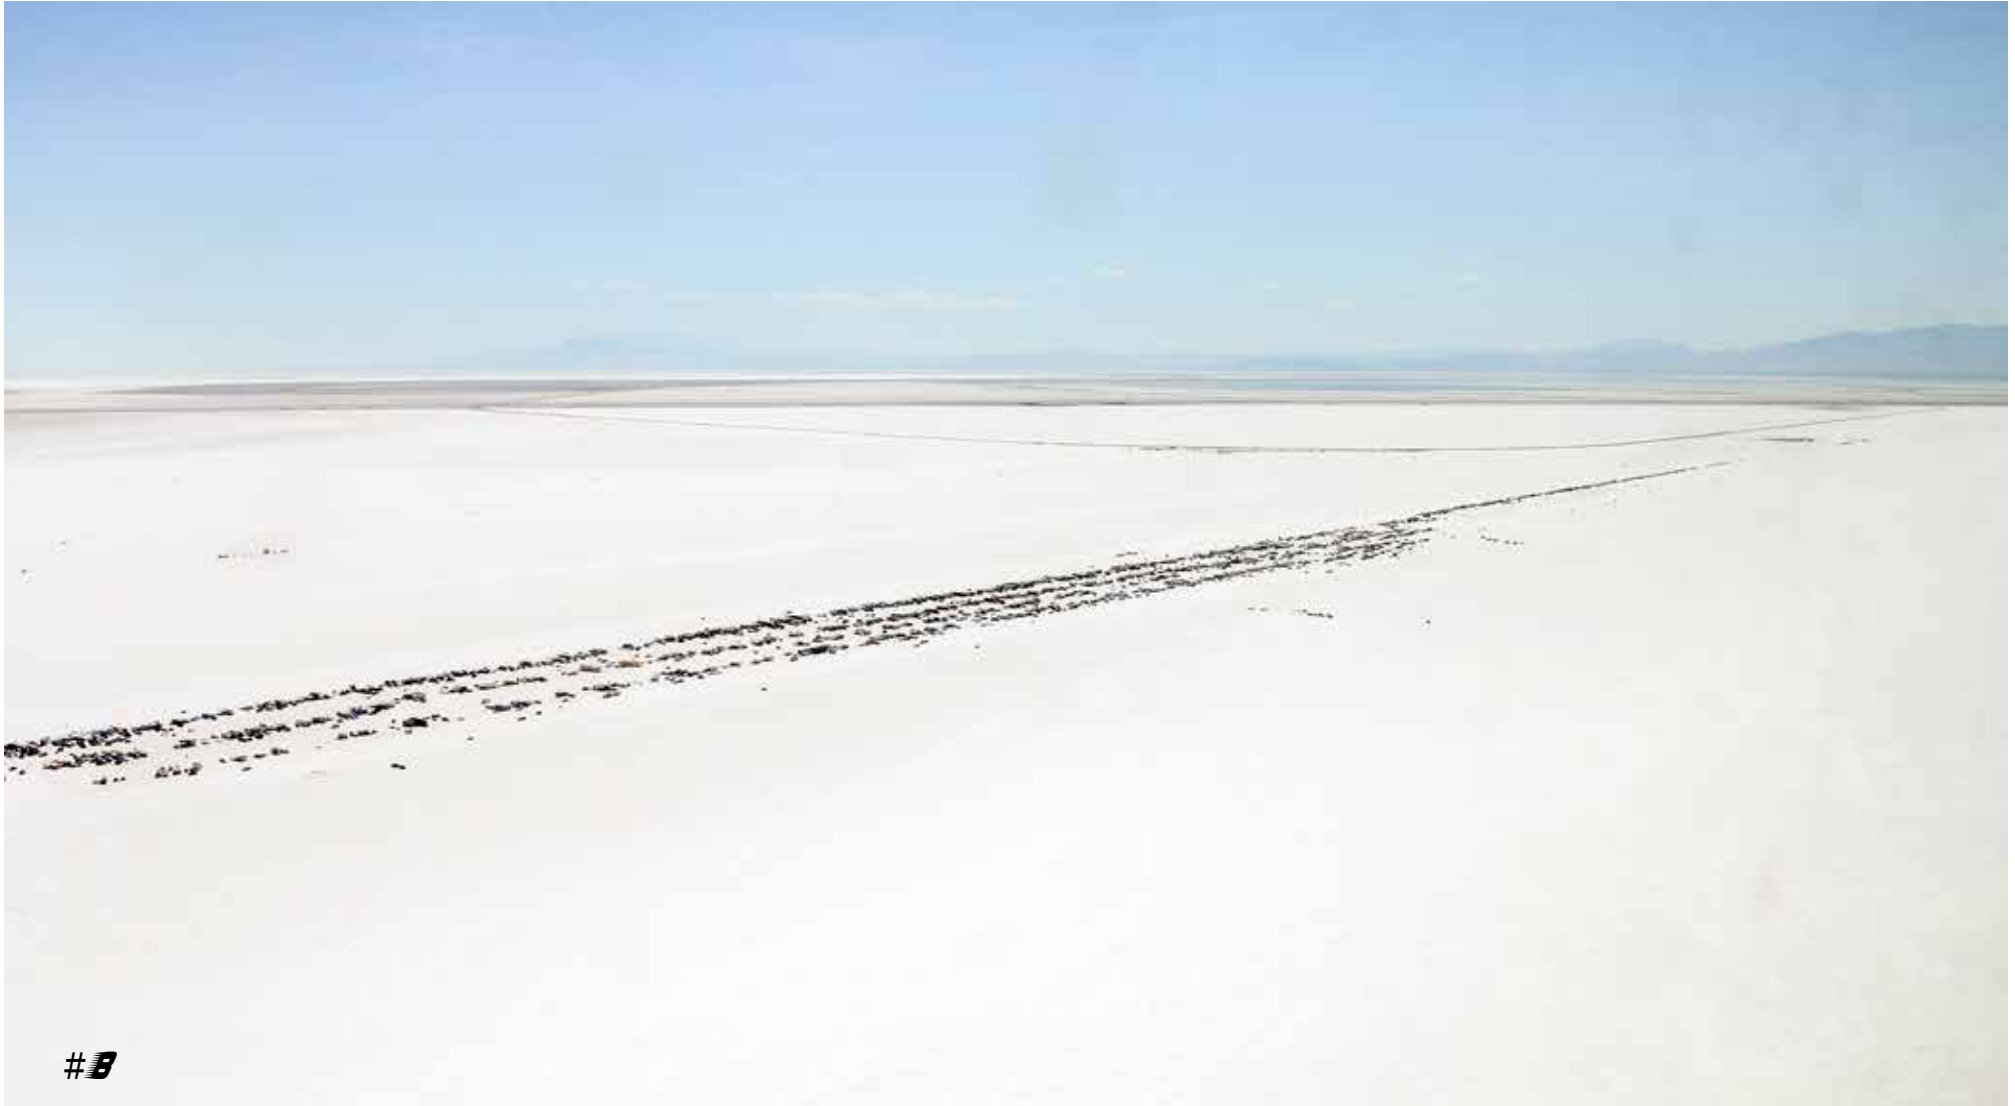
View looking southeast perpendicular to the long course at the pit area showing the decrease in salt thickness to the south and east along the federal collection ditch system. Again the salt surface extending to the south across I-80 is clearly visible all the way to the horizon. Close-up of the 2016 Speed Week pits that spread out over one-linear mile and

1/8 mile wide at the start of the event thinning to less than 75% of the racing entries by Tuesday when safe racing surface conditions withered dramatically. The tiny white trailer in middle left of the image is the long course timing tower and weather station. A vehicle is on course nearly even with timers.

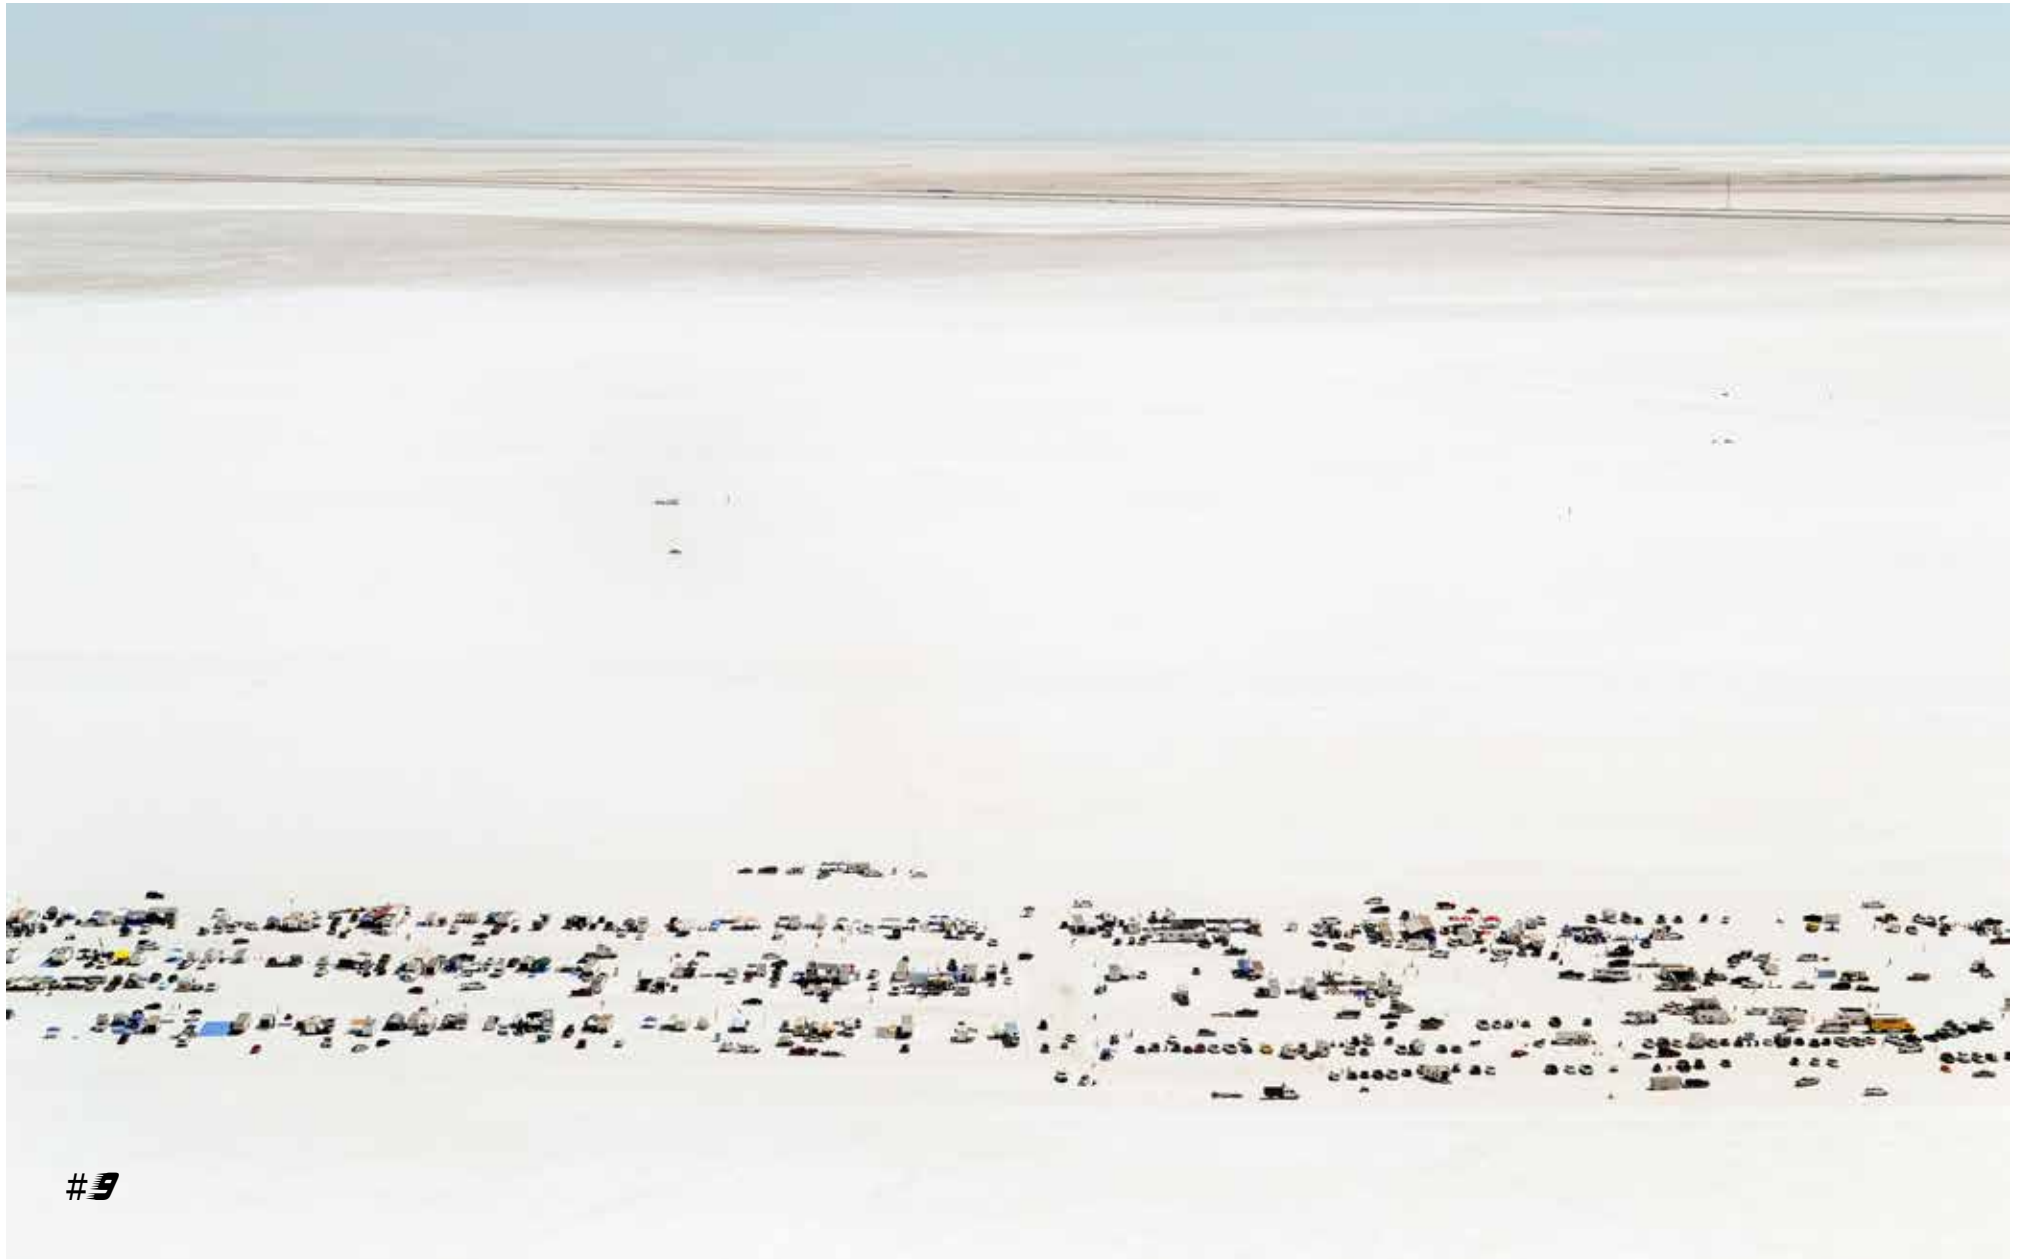
View looking east across the pit area and race courses showing the standing water and salt thickness depletion along the federal collection ditch.

The salt surface extending to the south across I-80 is clearly visible all the way to the horizon. The glazed, grayish line to the right of the pits is the long course race track.
