SPEED WEEK

BONNEVILLE SALT FLATS

AUGUST 13-19 2016

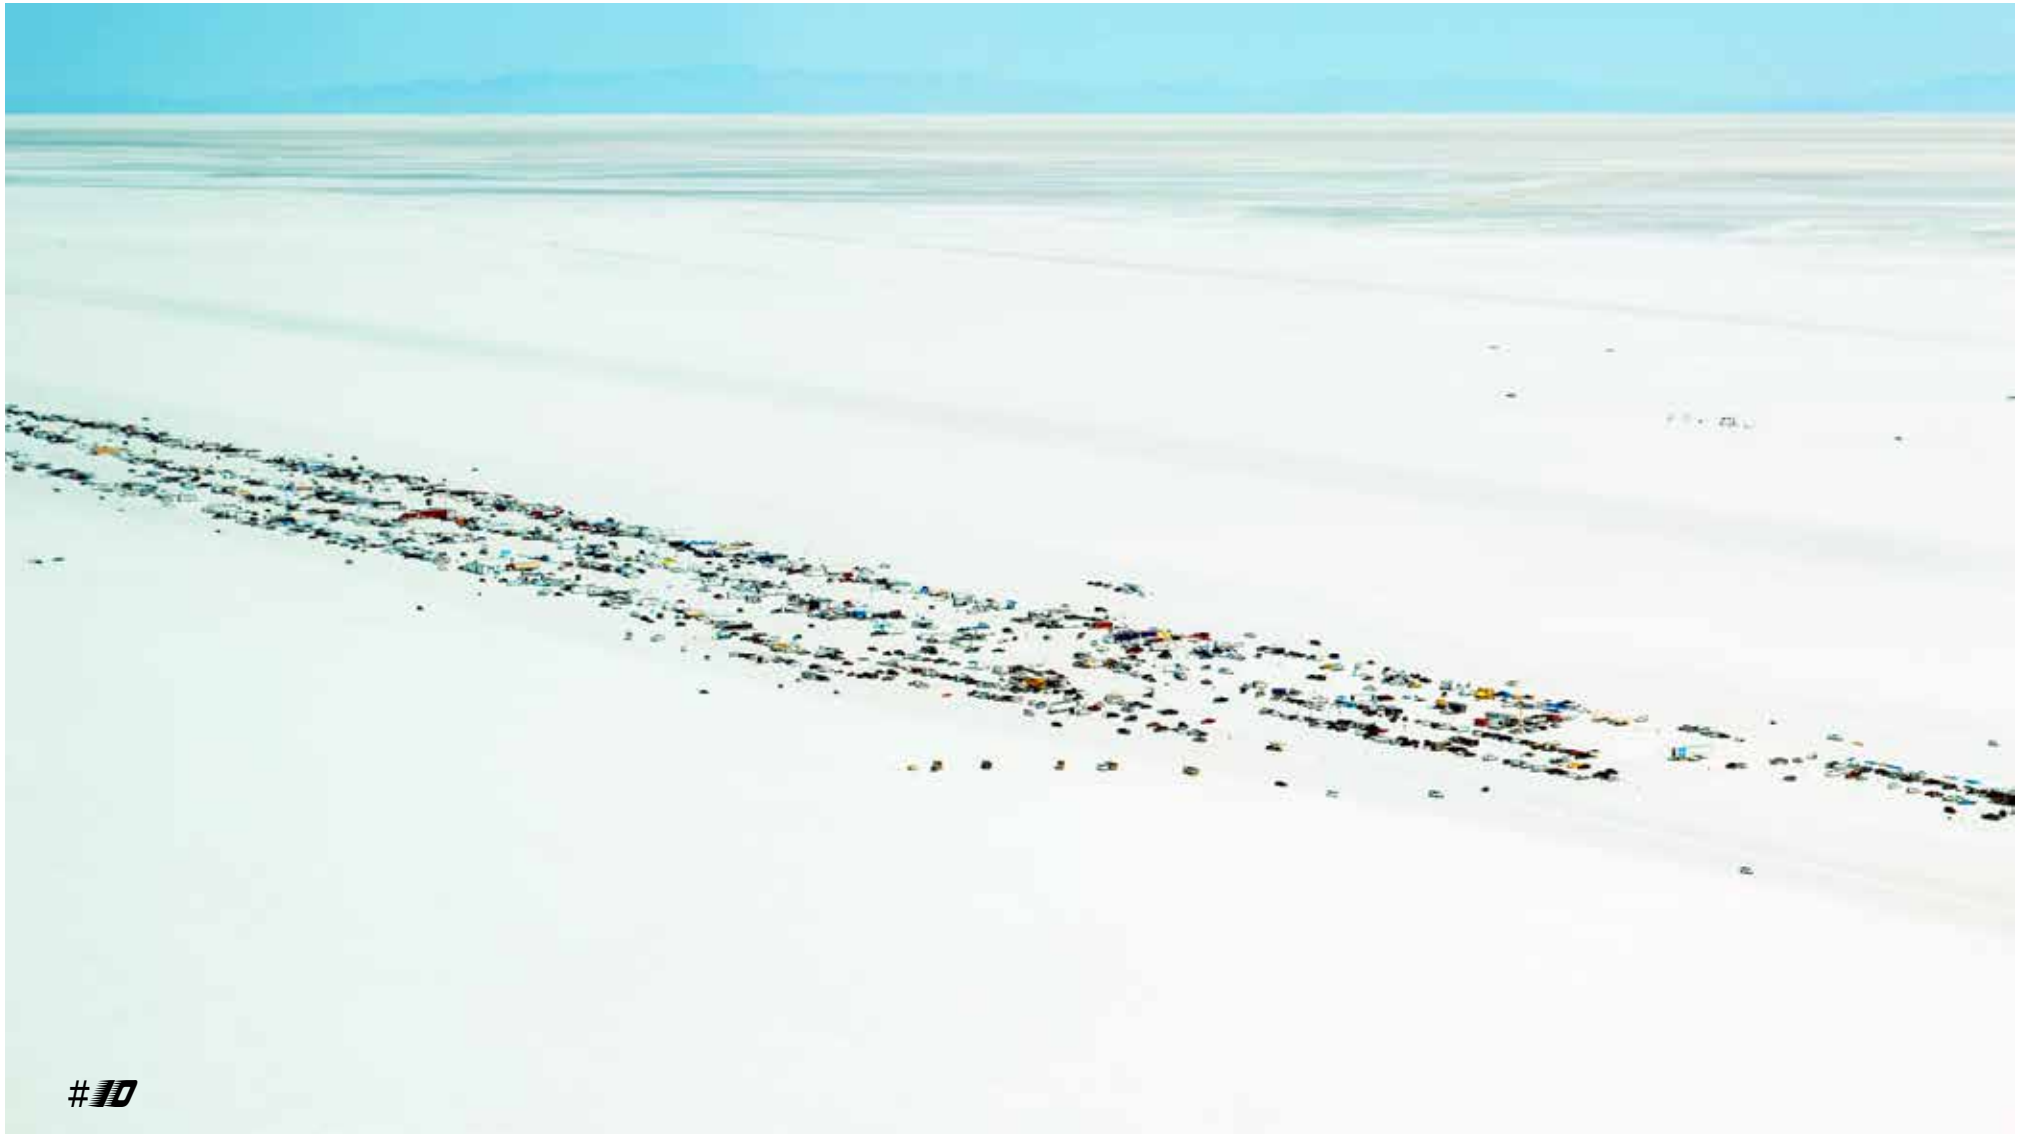
View looking due west towards Wendover and the paved access road from I-80 exit 4. Note the brown surfaces and vegetation extending out from the Silver Island Mountain Range indicating very thin salt surfaces. In the early days of land speed racing (before the paved access road, Interstate 80 with exit 4) access to the salt was gained from Highway 40, a few miles east of Wendover by driving off the north shoulder of the road directly onto the hard white salt surface.

This access existed before mineral extraction progressed to the current industrial scale under BLM leases that resulted in the massive transfer

of salt to the south side of I-80. Today these areas are nearly completely bare of salt and vegetation grows in the underlying dirt. All the dikes and ditches were significantly smaller before the BLM started issues mineral extraction leases.

Before potash mining was legalized racers recall the hard white salt extended all the way back to the “bend in the road” and there was no vegetation to be seen along the last four miles of that road as you headed east to the entry point. The 2 arcing roads on the left of the image is the exit ramp off I-80 into Wendover, Utah.

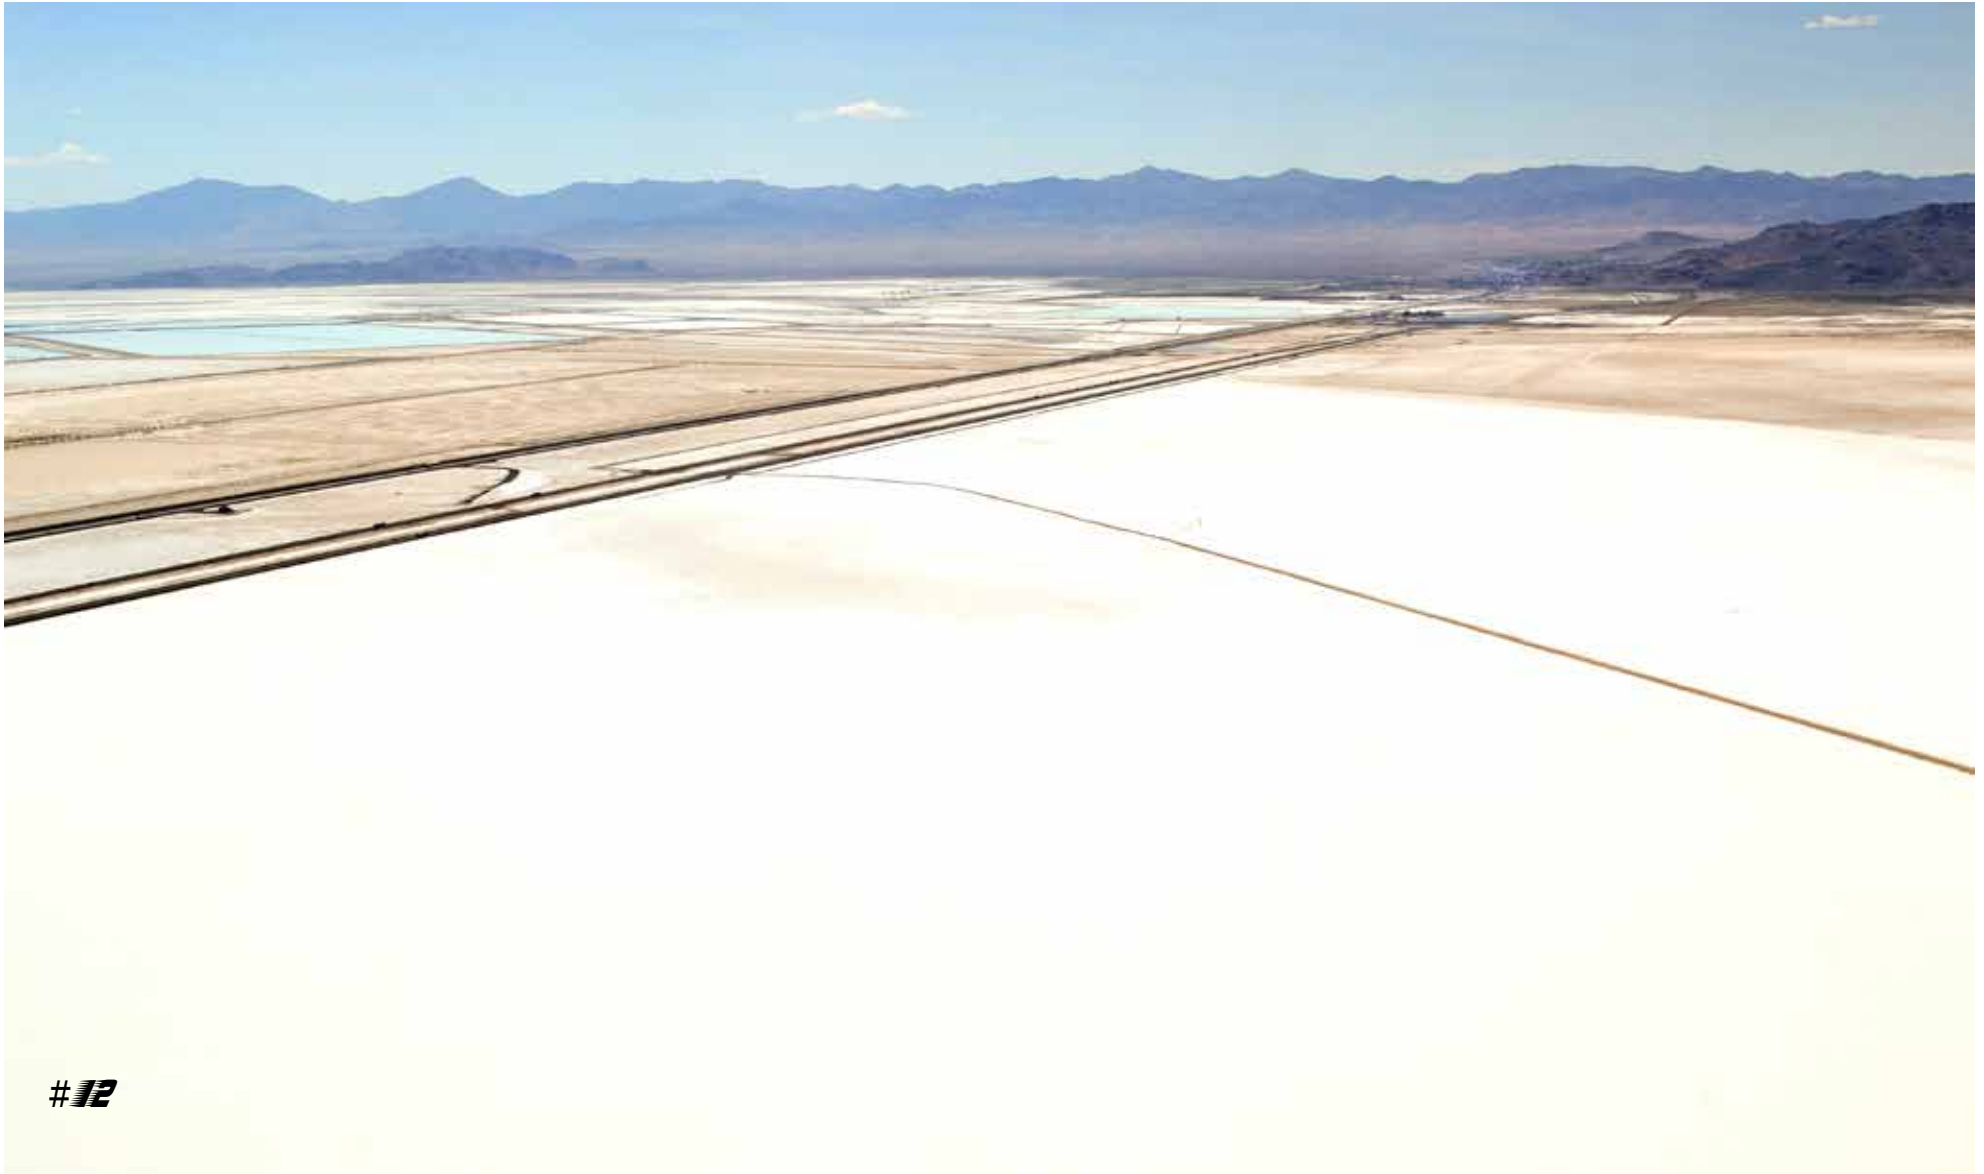
View looking north with Graham and Cobb Peaks near the north end of the Silver Island Mountain Range in the background. The federal collection ditch is in the foreground with its massive mud dispersion out over the salt due to wind, rain, erosion, and transient winter pond damage. The brown surface at the base of the Silver Island Mountain Range indicates very thin salt over this large distance. The only usable salt surface is where the long course was laid out, and it practically ended at about 7 miles, roughly where the small black spot near the left center of this frame. In recent past years there has been a salt “finger” extending along the collec-

tion dike nearly to Floating Island, another 4 miles beyond where the salt stops in this photo. This area is where the International return runs would have started, but with no salt to run on they are now forced to use significantly shorter distances. Many of the faster vehicles opted out of international record attempts held late in September due to this condition. Just out of sight at the bottom of the picture, the ditch turns to the left and proceeds to the mining company’s settling ponds on the other side of I80. You can see as the ditch zig-zags off into the distance, the once white pure salt surface has been leached out so that only basic mud remains with a few tiny thin traces of remaining salt in rare spots. This federally approved (and federally funded / installed) extraction process has been underway for over 60 years and the Land Management authorities still can not determine where the salt has gone or why the salt surface has been depleted. As a “Salt extraction” device and process – one could observe that it has worked very well. One could also wonder if it might work as well as a “Salt Return” process as it did as a “Salt Removal” process.
